Lake Marian Bathymetry Study

Prepared for:

Lake Linganore Homeowners Association
6718 Coldstream Drive
New Market, Maryland 21774

June 2022

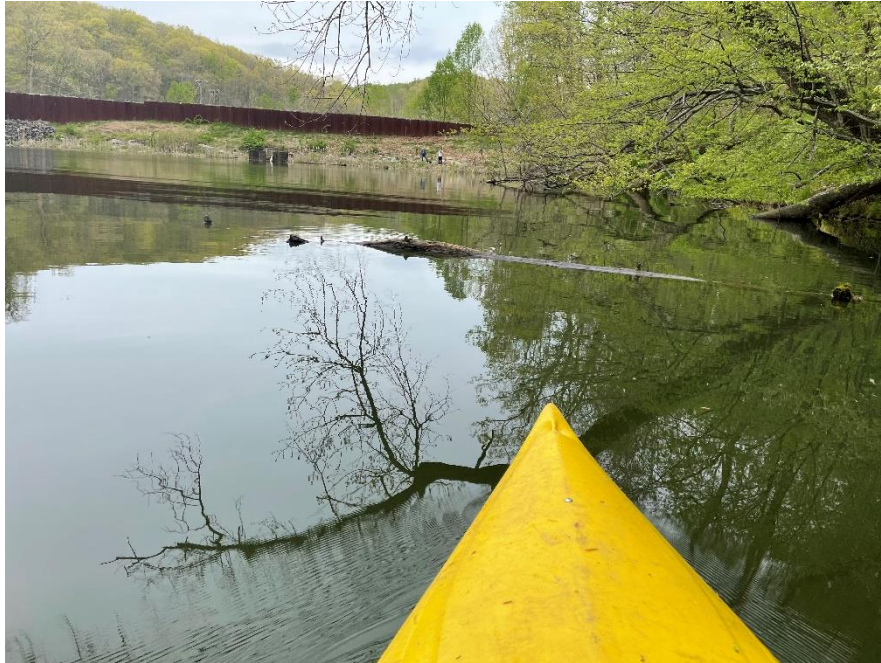
Figure 3: Example of entanglement hazard encountered during Lake Marian bathymetric survey, April 30, 2022.

On April 30, 2022, ASV-generated bathymetry data were collected on Lake Marian along parallel transects in a grid pattern resulting in over 5000 depth measurements. In select locations, a tow-and-record pattern (kayak towing the boat while collecting data), was used to avoid obstructions and reach closer to the lake perimeter. Some perimeter sites were too shallow (<3 ft) to record measurements and several lake locations contained entanglement hazards (e.g., over hanging or partially submerged trees) for the ASV, so measurements were taken less frequently in these areas. (See Figure 3).

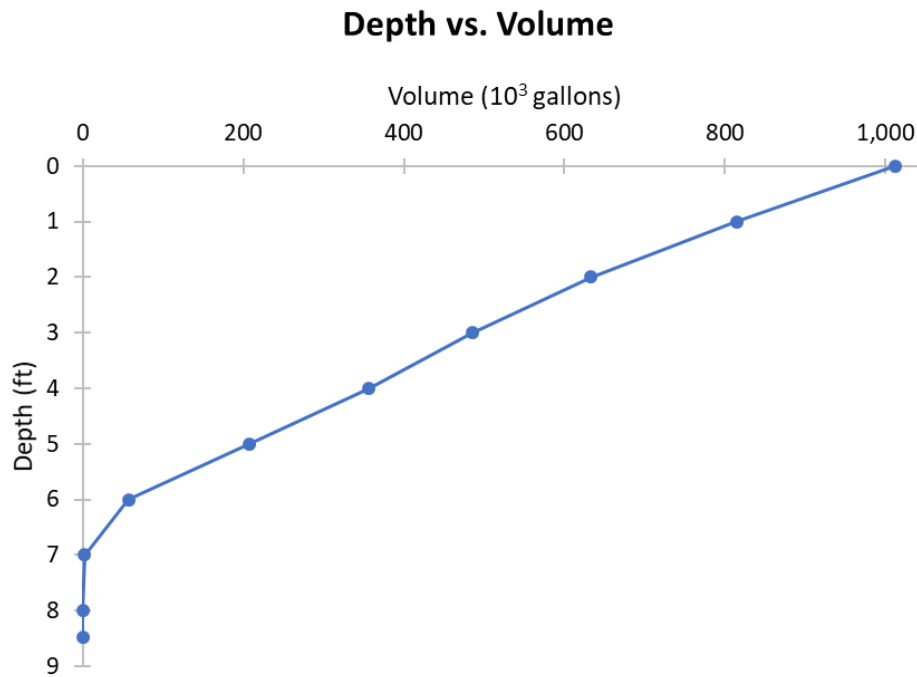
Figure 55: Lake Marian volume vs depth curve, April 2022

Depth versus volume and depth versus surface area curves are provided in Figures 5 and 6, respectively. These relationships can be used in lake management decisions that might include application of compounds for mitigation of harmful algal blooms (for example hydrogen peroxide dosage calculations). They can also provide the basis for understanding whole lake ecological processes.

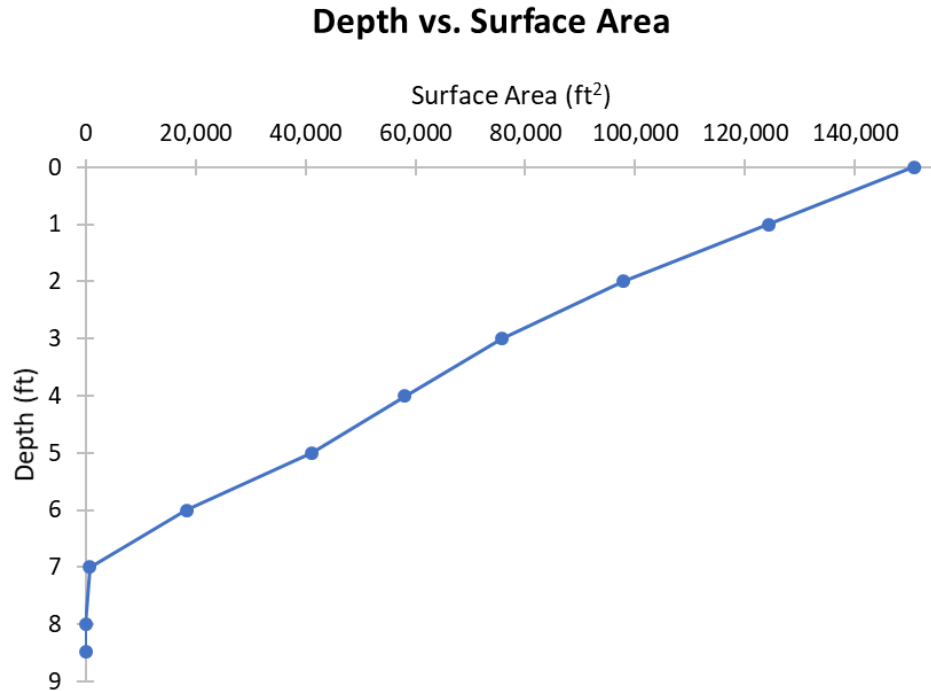
Figure 66: Lake Marian surface area vs depth curve, April 2022
